# Wenden Elementary School Limited Exterior Asbestos Report

Wenden Elementary School  
71001 Santa Fe Avenue  
Wenden, Arizona 85357

Wenden Elementary School District No. 19  
71001 Santa Fe Avenue  
PO Box 8  
Wenden, Arizona 85357

Inspection Date February 19, 2019

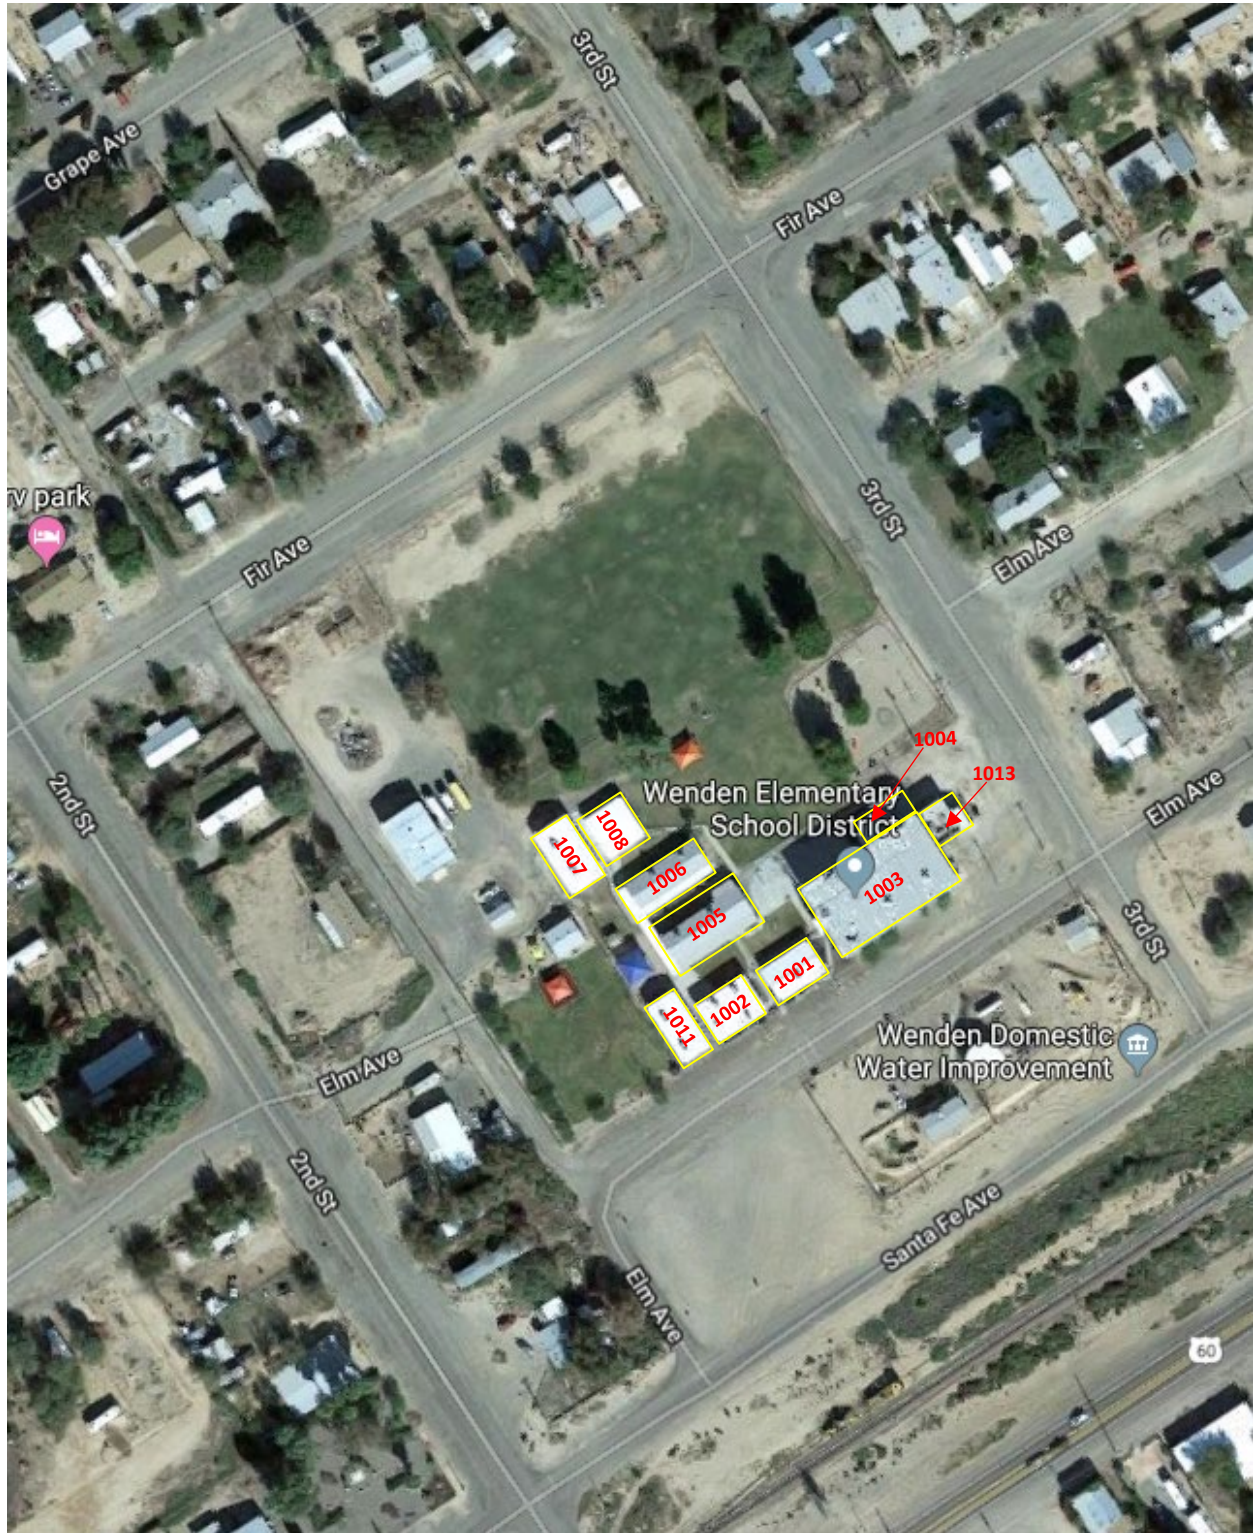
## SITE MAP

Site Overview of Wenden Elementary School.

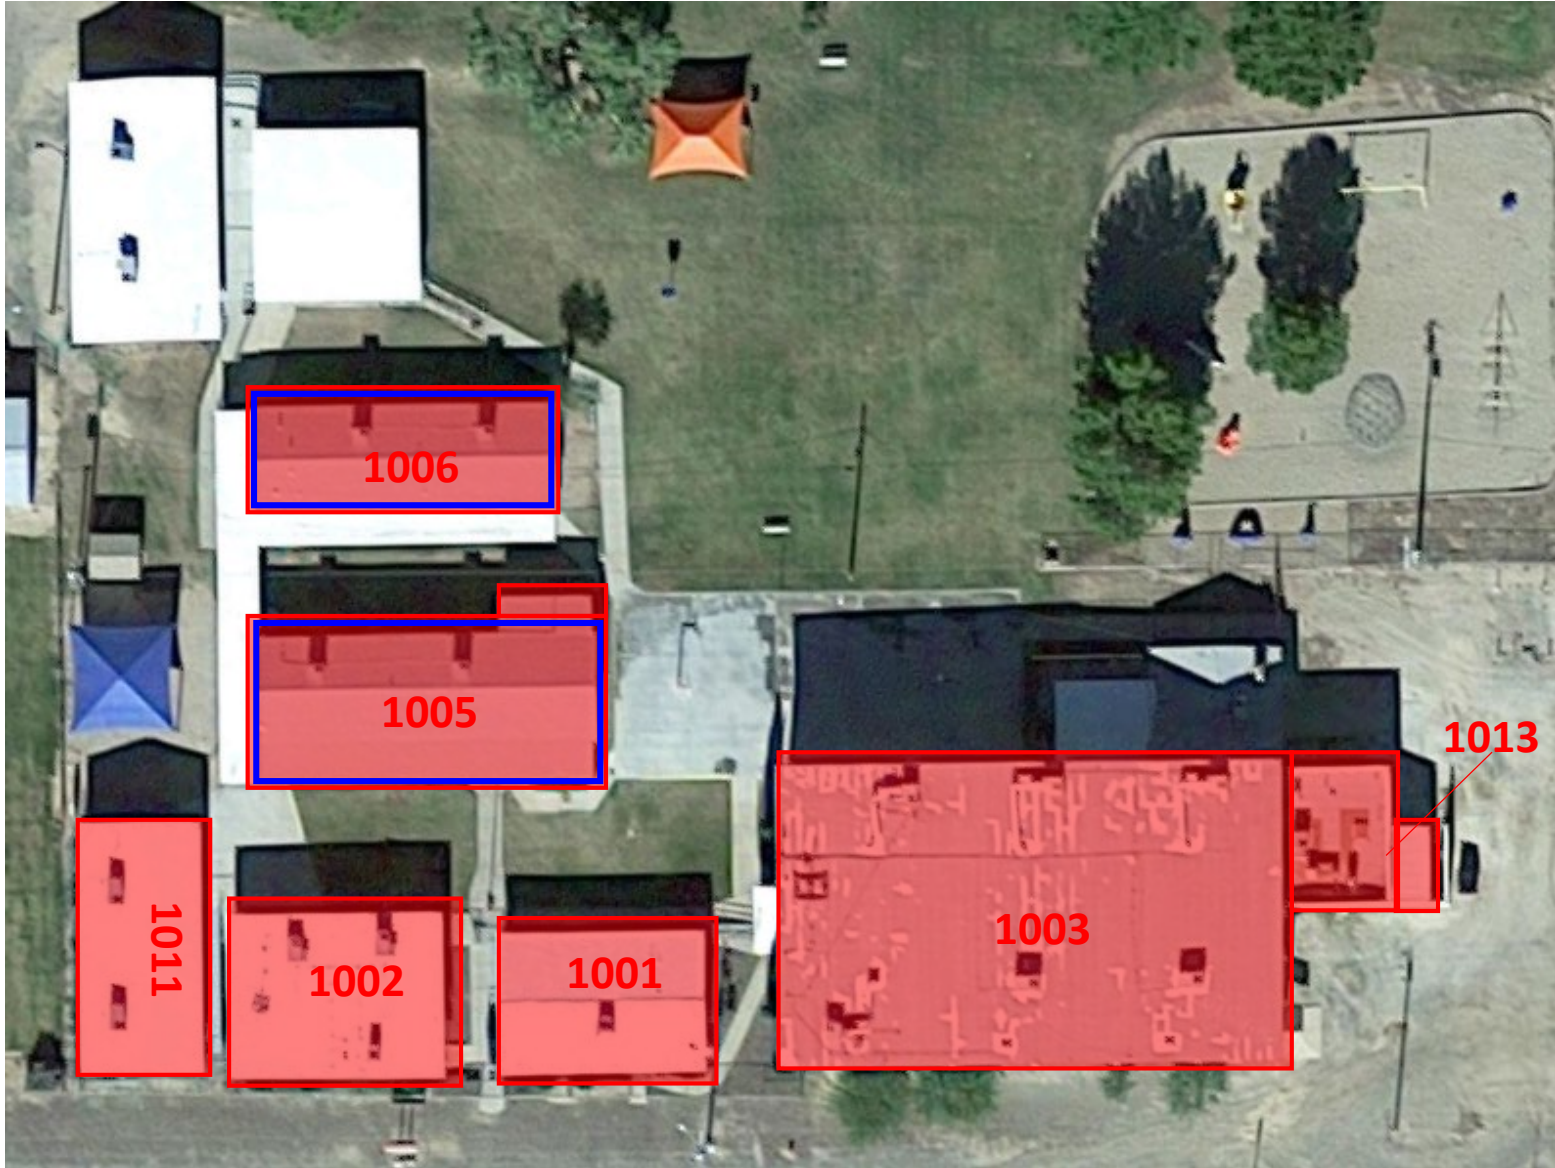
# ASBESTOS-CONTAINING MATERIAL & <1% ASBESTOS MATERIAL LOCATION MAP

### Asbestos-Containing Material Location

**Building 1001**

RTC recommends that the previously referenced asbestos-containing material (ACM) be removed by a qualified asbestos abatement contractor. The contractor should comply with all governing regulatory agencies guidelines.
